Preservation Management Plan for the Elm Street Cemetery Braintree, Massachusetts Volume I: Report

Prepared for:
The Town of Braintree
Braintree, Massachusetts
February, 2011

Barbara Donohue, RPA

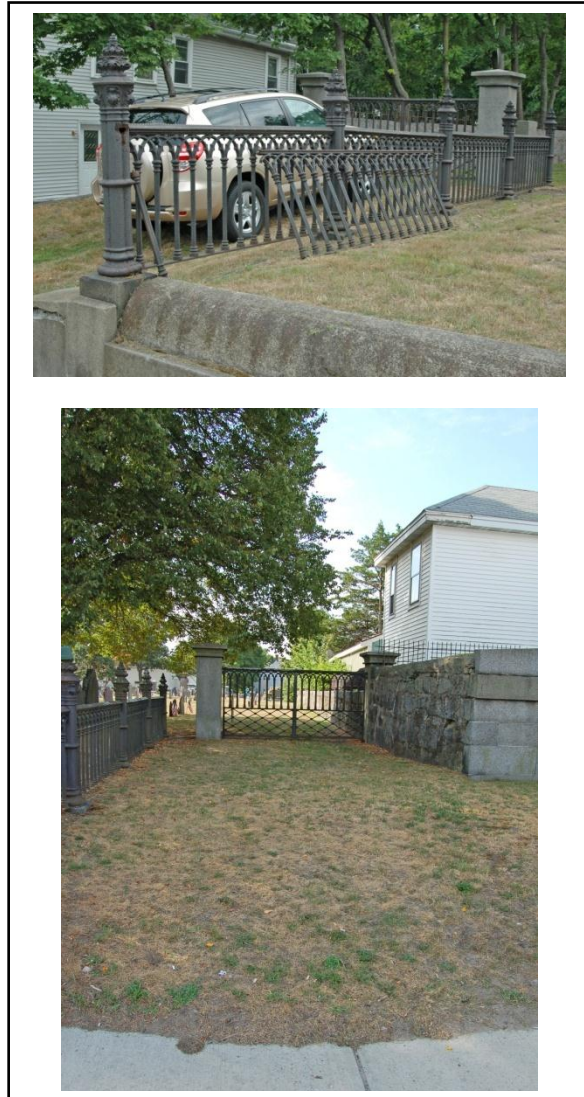
Today access into the cemetery is by way of Elm or Railroad streets. There are two double entrance gates measuring 9'6" at the northwest and northeast corners of the cemetery, with grassed entryways leading to both. The northeastern entrance is steeper than the northwestern entrance. The gates, while closed, are not locked (Figure 3-9).

Figure 3-9. Entrances to the cemetery. Top photograph shows the east entrance. Bottom shows the west entrance.

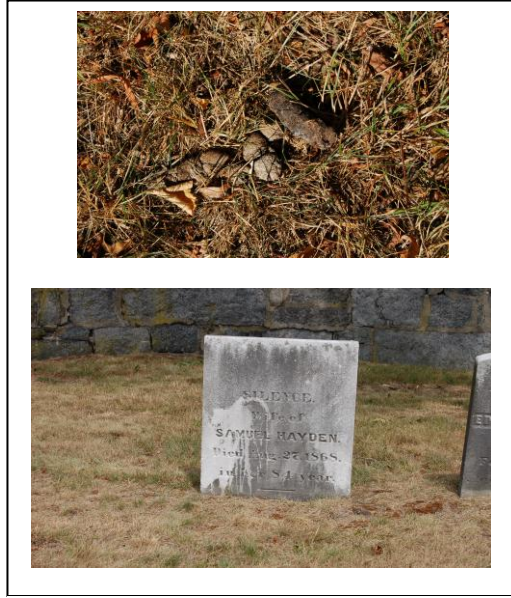
Figure 3-10. Damage caused by dogs in the cemetery. Top photograph shows dog feces in the cemetery. Bottom photograph shows damage done to a stone by dog urine.

The town already has an ordinance requiring all animals be leashed (6.04.060), as well as making it a criminal violation to allow an animal to defecate on public property (6.04.130). These laws must be enforced.

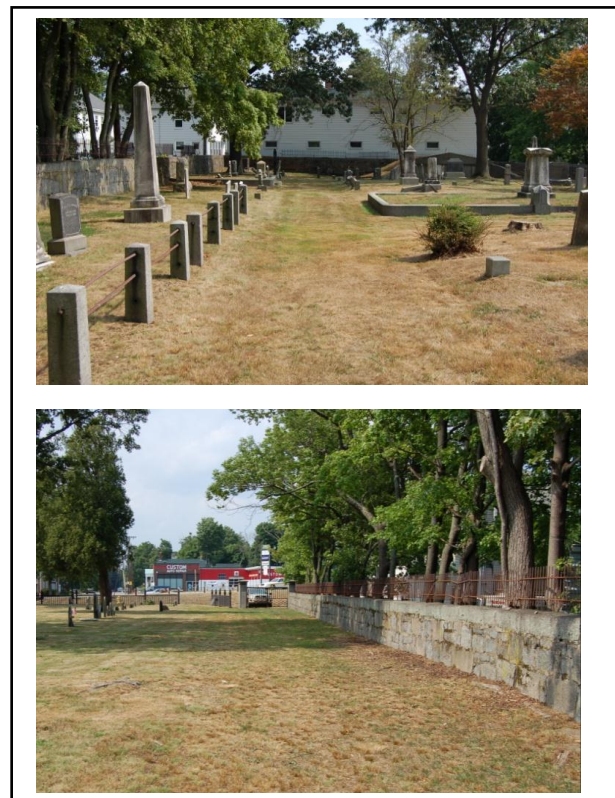
There are no clearly defined pathways in the cemetery (Figure 3-11). This is also not considered a significant problem. Cemetery use is light at present. It is unlikely that paths would have been part of the layout of the original (northern) portion of the cemetery. Such designs tend to maximize available plots and there was little thought given to pedestrian movement since cemetery visitation was limited to burials.

Figure 3-11. Examples of the pathways in the cemetery. Top photograph shows the carriage way on the east side of the southern section. Bottom photographs shows the open passage along the east side in the north section.

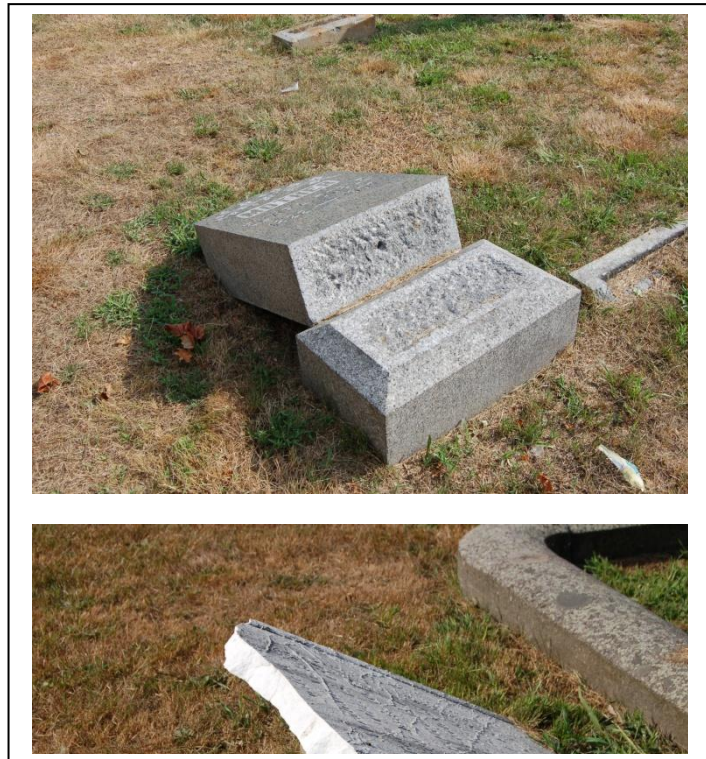
Figure 3-12. Examples of recently vandalized stones. The top photograph shows a heavy stone on a level base that would not have toppled without assistance. The lower photograph shows a freshly broken marble edge.

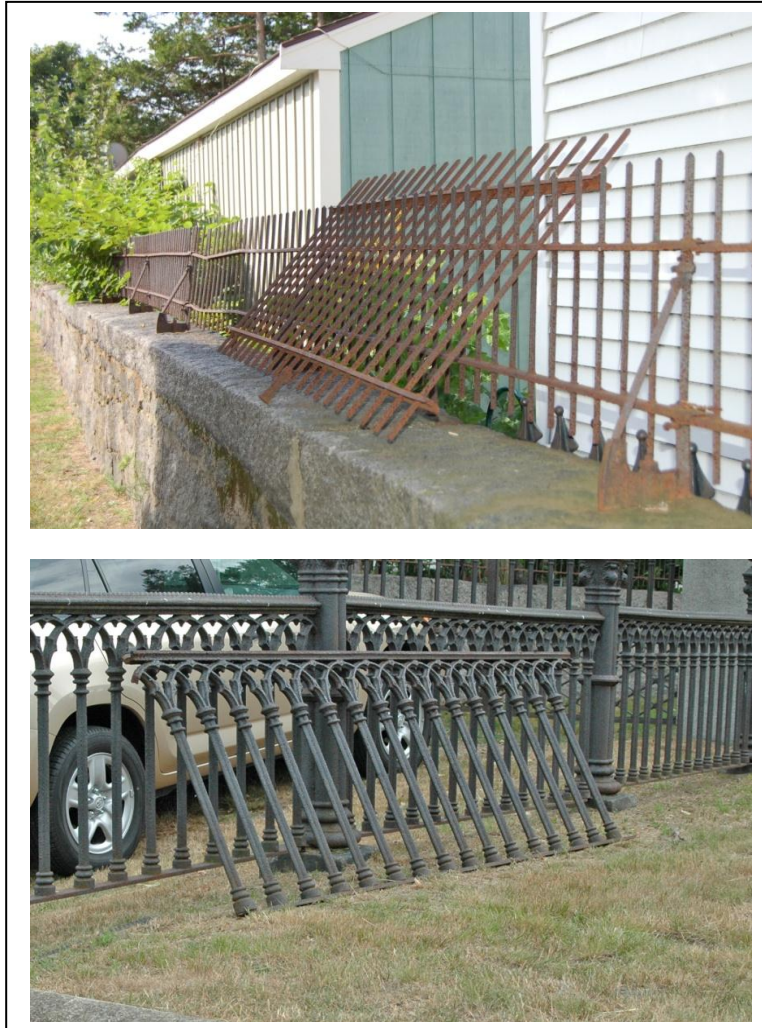
Figure 3-13. Examples of ironwork that should be secured and protected. Leaving these items scattered in the cemetery is disrespectful and invites theft of irreplaceable historic fabric.

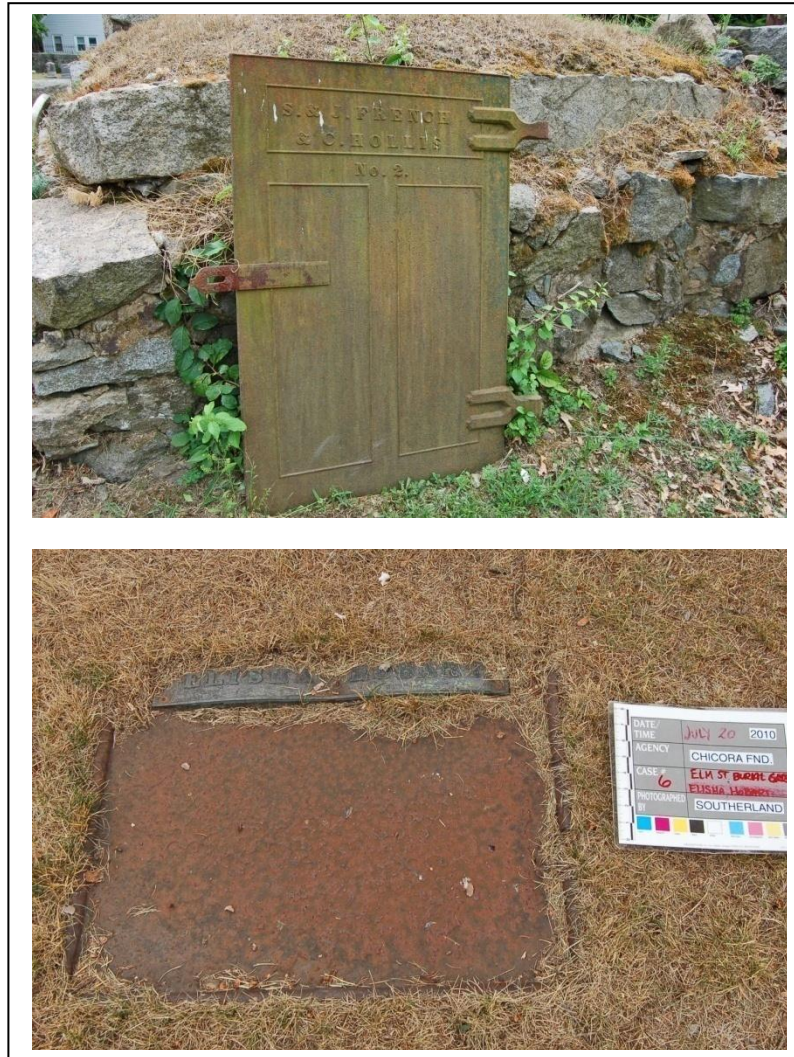
Figure 3-14. Remnants of two tombs demolished by the town ca. 1991.

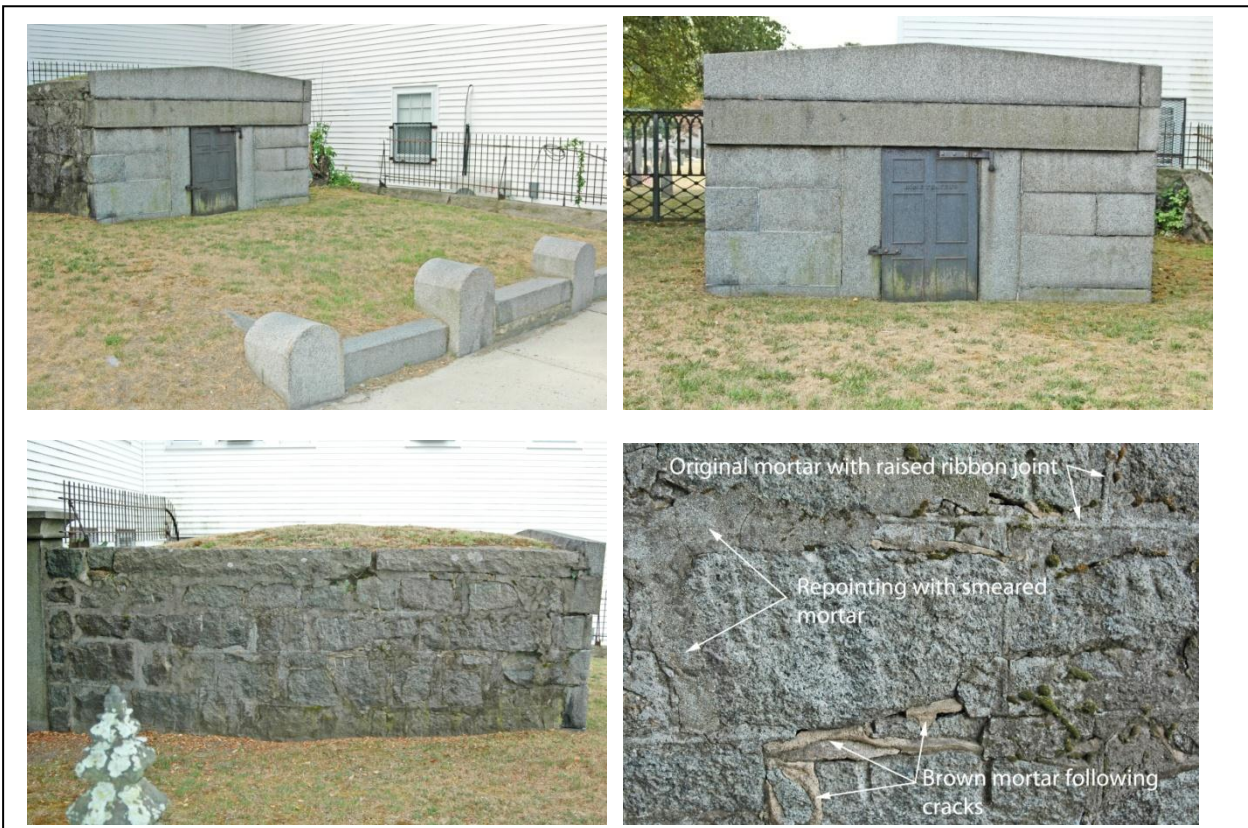
Figure 3-15. Honorable E. Thayer tomb. Upper left is the Thayer yard. Upper right is the front (north) façade. Lower left is the east façade. Lower right is a close-up of the east façade showing different mortars.

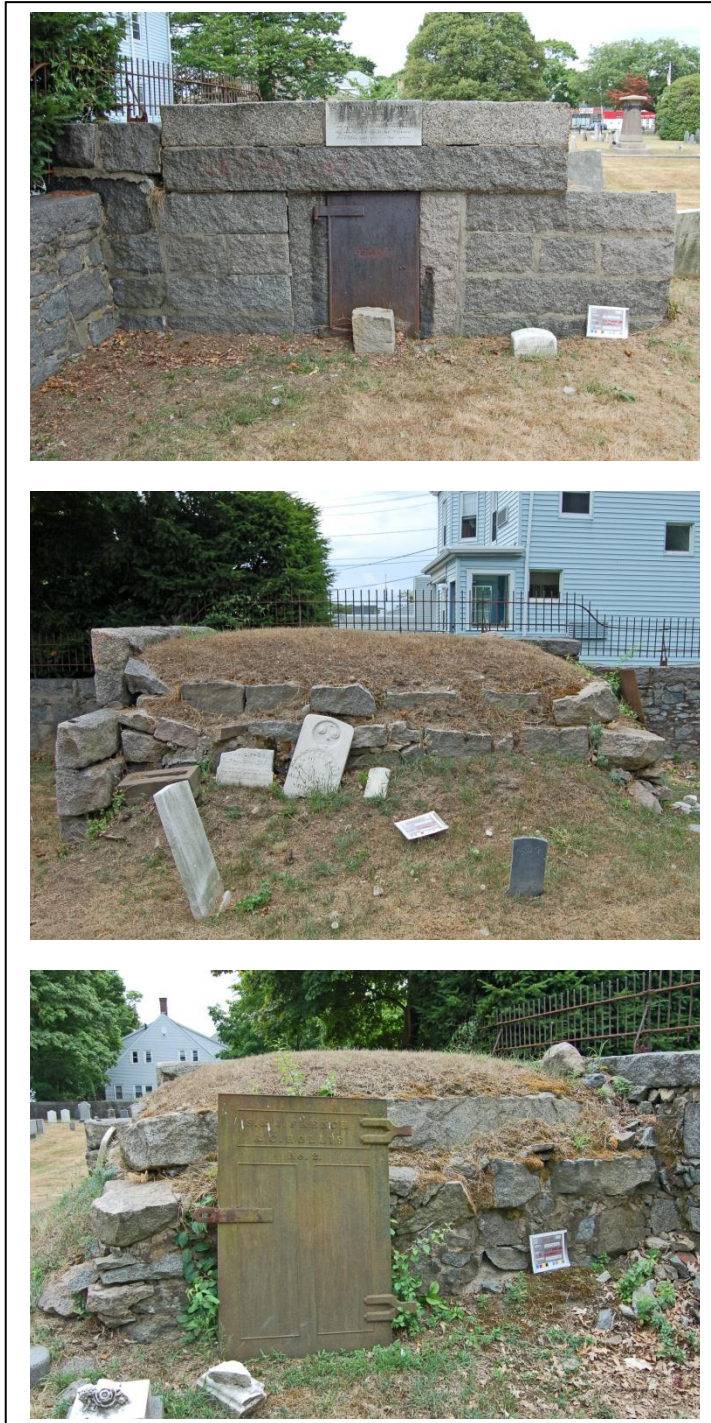
Figure 3-16. S.V. Arnold tomb. Top photograph shows the south façade. Middle photograph shows the east façade. Bottom illustrates the north façade.

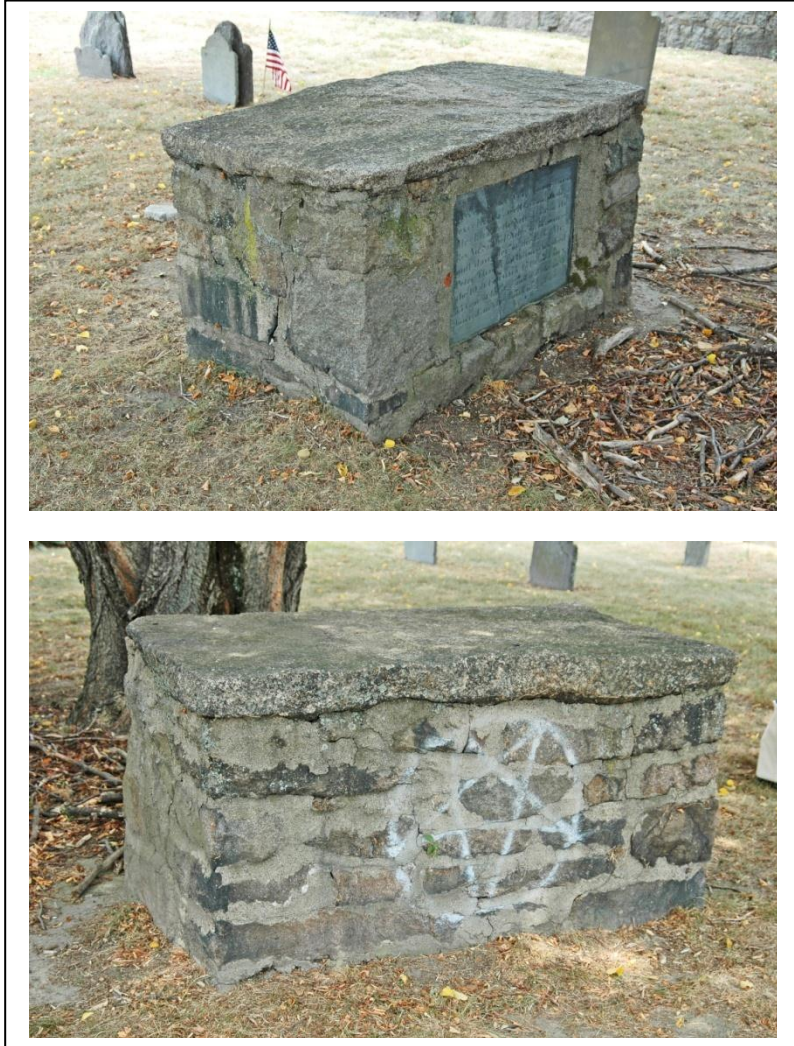
Figure 3-18. Elizabeth Niles box tomb. Top photograph shows the north and east facades. Bottom photograph shows the south and west facades.

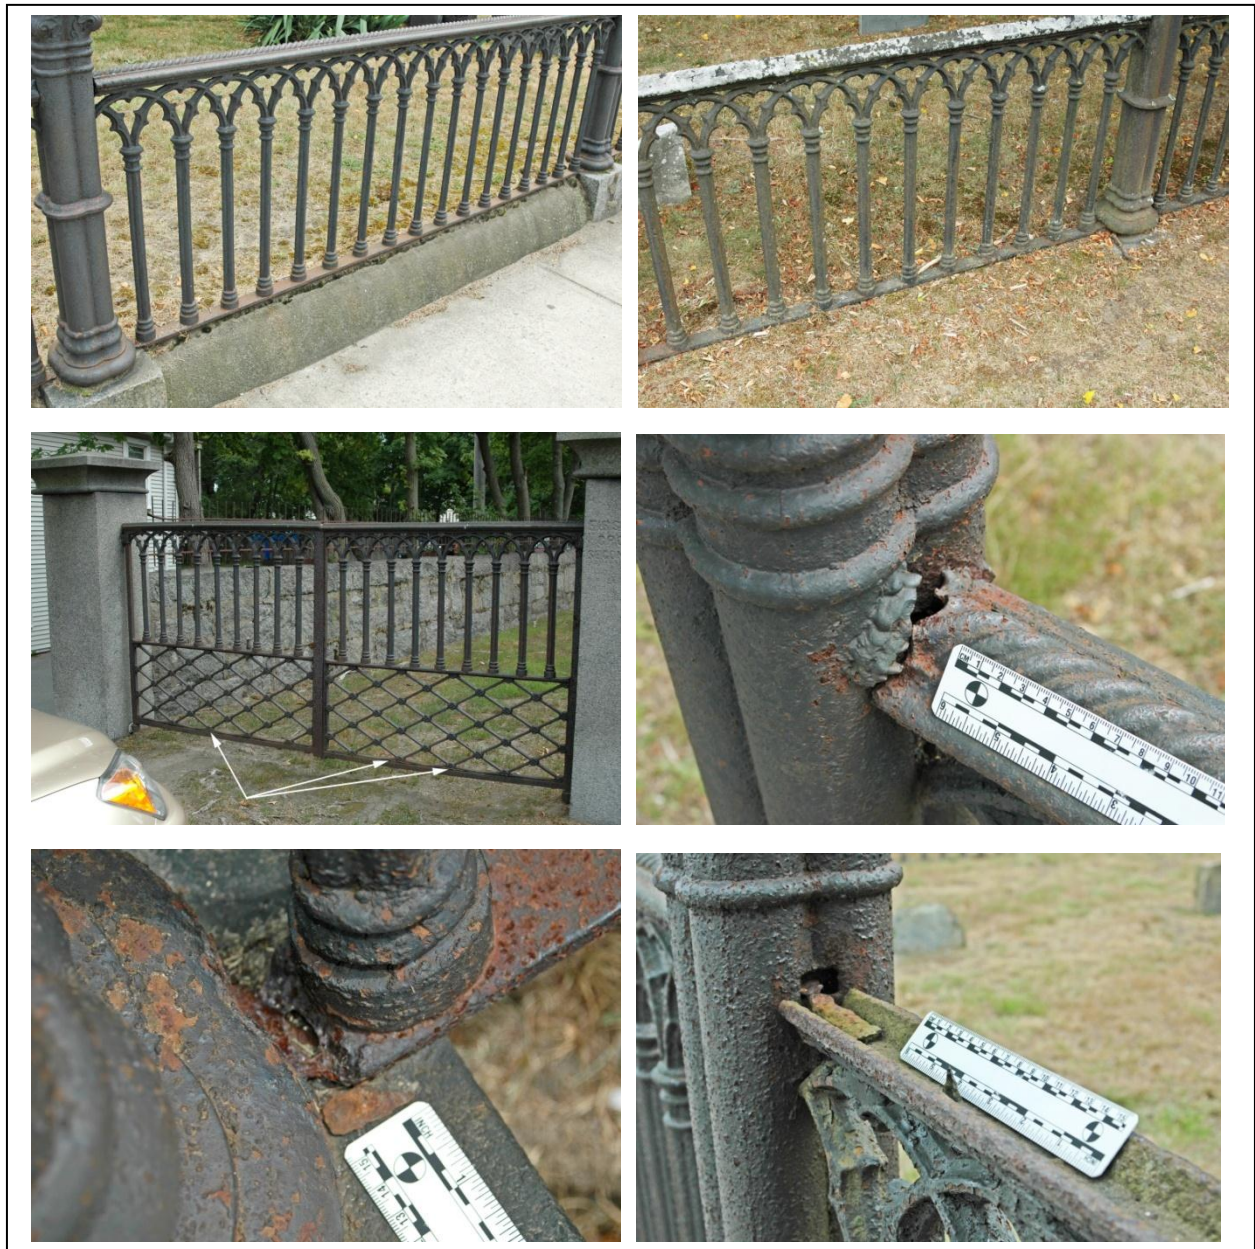
Figure 3-19. Elm Street fence. Upper left photo shows a fence section along Elm Street in the soil. Upper right photo shows a fence section at the west gate in the soil. Center left photo shows the east gate; note areas requiring caulking, as well as the displaced gate post caps. Center right photo shows a broken weld, as well as corrosion and pitting of the fence. Bottom left photo shows extensive corrosion at bottom rail connector. Bottom right photo missing top rail cover, as well as damaged connector.

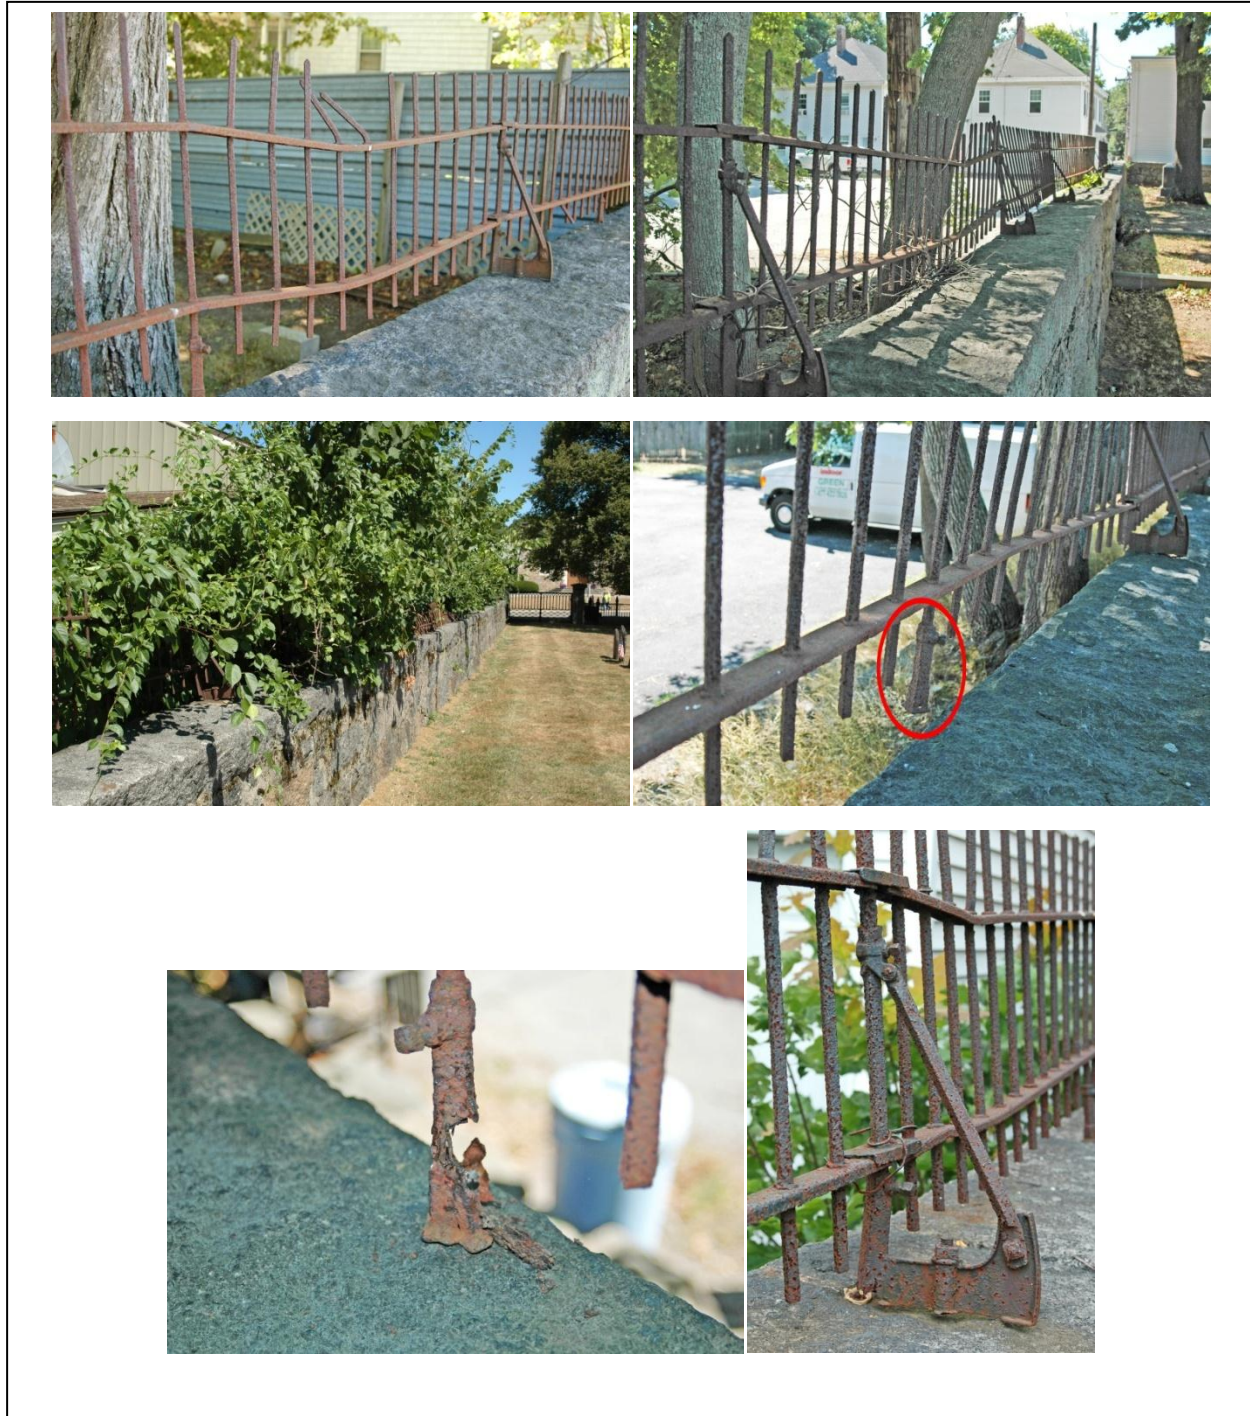
Figure 3-20. Perimeter fence. Upper left photo shows bent section from old tree or limb damage. Upper right shows ongoing damage from trees off the cemetery, leaning into the fence. Center left photo shows vegetation from adjacent parcels obscuring the fence. This trash vegetation should be removed. Center right photo shows a central panel support that is no longer attached to the stone wall. Lower left photo shows a central panel support that has completely failed because of extensive corrosion. Lower right photo shows a failed panel support. Note also the extensive corrosion on the fence and support.

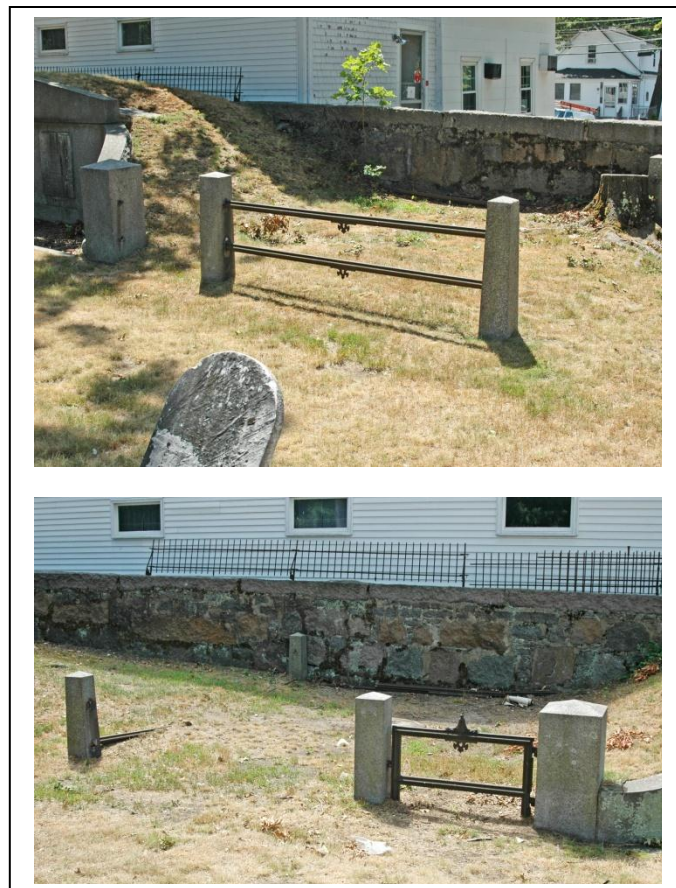
Figure 3-21. Vinton fence. Upper photo shows the fence on the west side of the tomb. Lower photo shows the fence on the east side of the tomb, with the gate buried in the soil and the lower side bar bent and covered in soil.

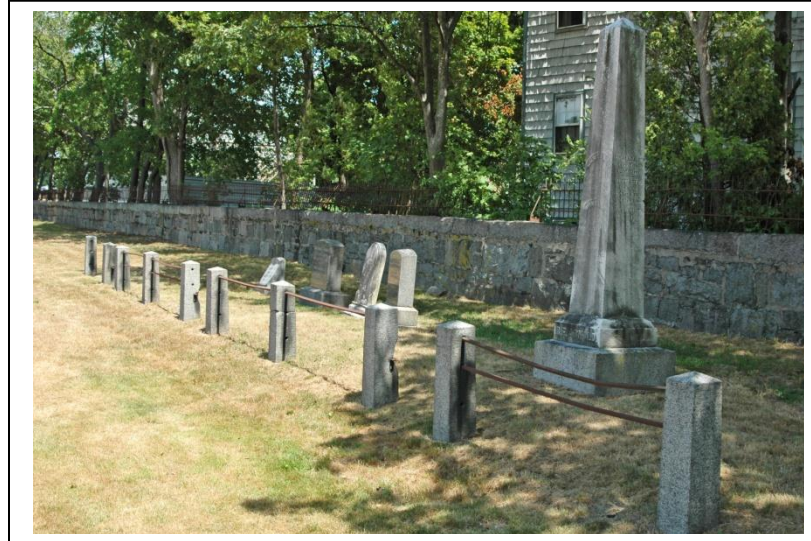
Figure 3-22. Arnold Family Plot fence.

At the east side of the cemetery the Arnold plot has a three rail iron fence set in granite posts (Figure 3-22). There is no indication that the north and south edges of the plot were enclosed, but the fence and three gates ran along the west side of the plot (the east side bounded the granite perimeter wall).

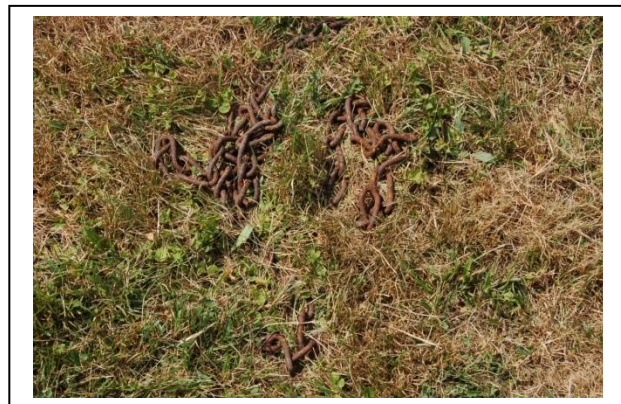
Figure 3-23. Portion of the chain from the French plot found scattered in the cemetery.

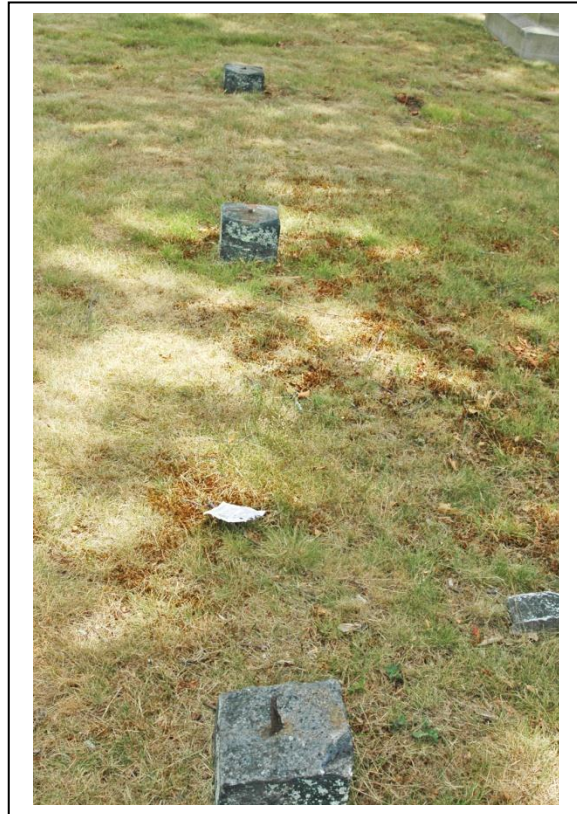
Figure 3-24. Lost fence documented by granite blocks and remnant iron rods.

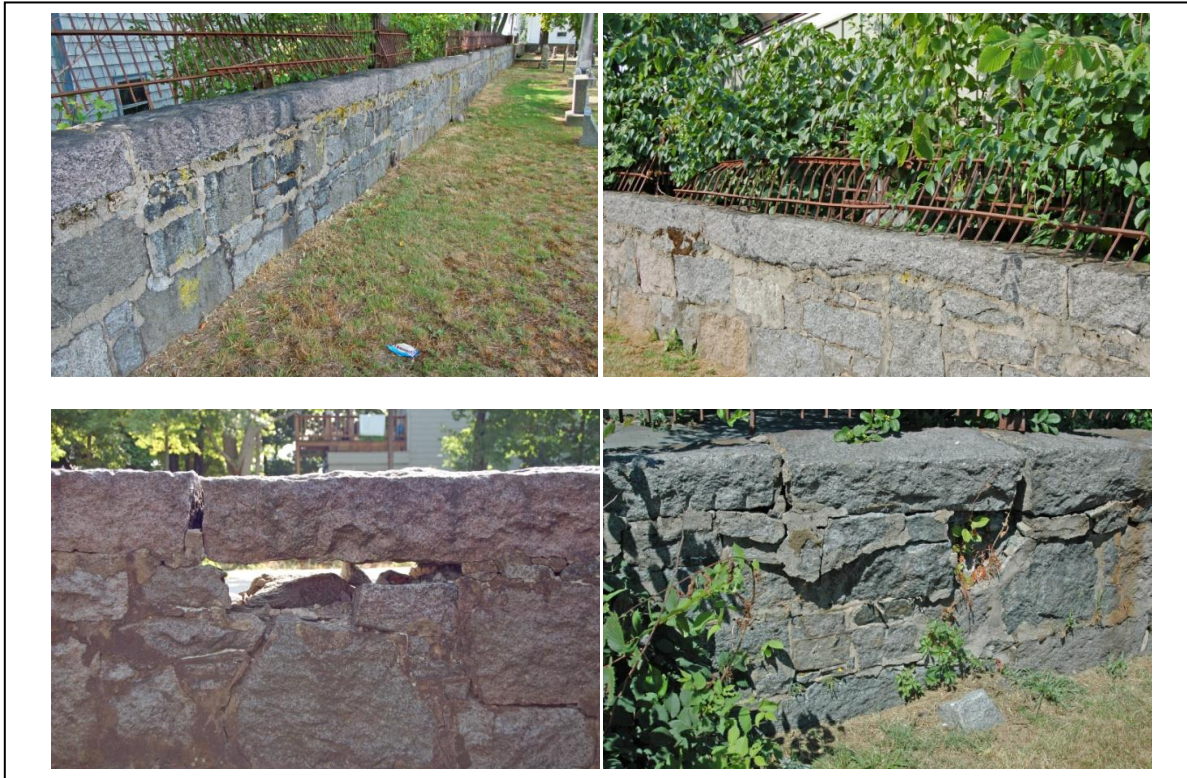
Figure 3-25. Perimeter granite wall. Top left photo shows the wall on the east side of the cemetery. Top right photo shows the wall on the west side of the cemetery. Lower left photo shows the damage to the south end of the east wall. Lower right photo shows the damage to the south end of the west wall.

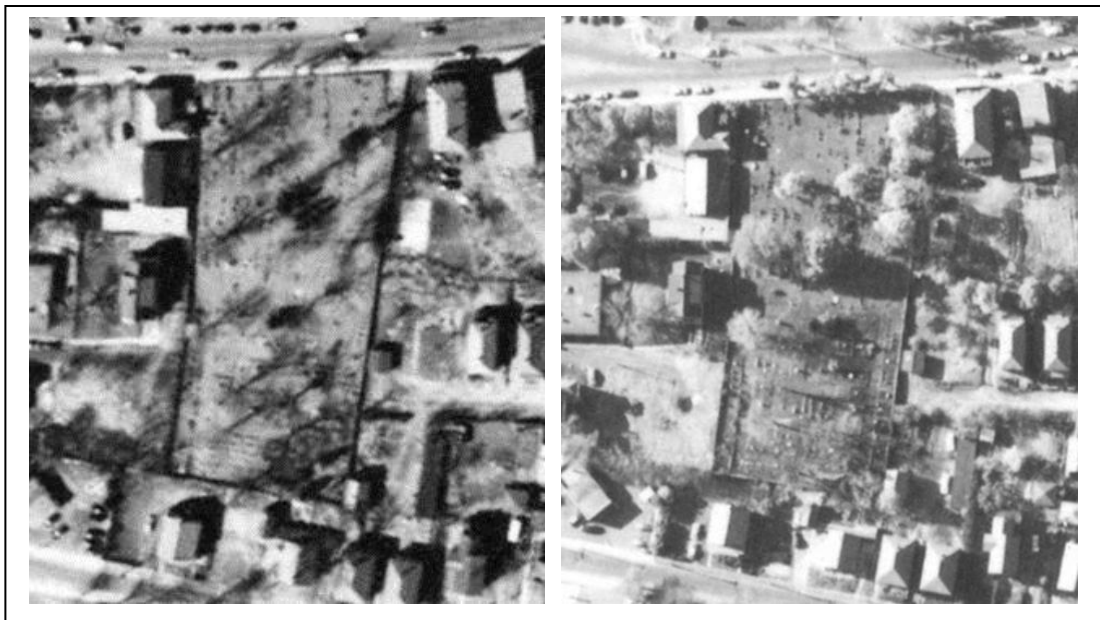
Considering the years of neglect, it is likely that by the early 1990s many of the original plantings had succumbed. It is also likely that some of the plantings, such as the Japanese maple, were rather recent introductions into the cemetery landscape (based on their size). Although some reduction in landscape plantings is recognizable on historic aerial photographs for the 1940s and 1950s, it is clear that the greatest loss occurred during the late 1990s (Figure 3-27).

Figure 3-27. Aerial photographs of the cemetery in the mid-twentieth century. On the left is an April 1947 photograph. On the right is a photograph from May 1954.

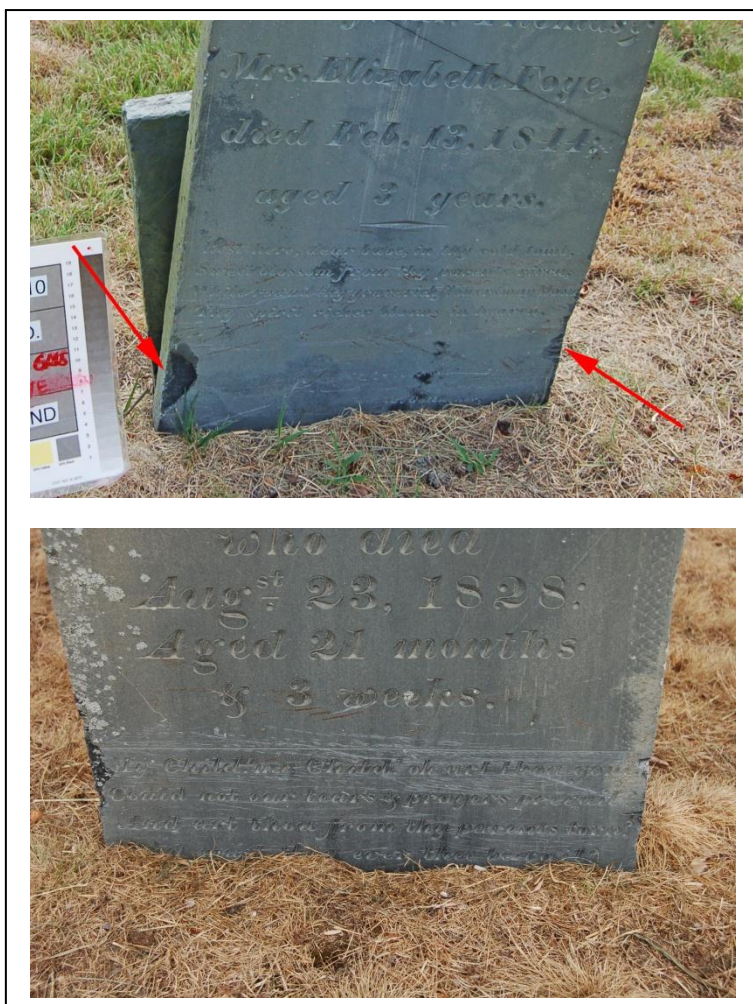
Figure 3-28. Examples of mower and trimmer damage. Top photo shows mower impacts on the sides of a slate stone. The bottom photo shows parallel scars from too heavy nylon trimmer line.

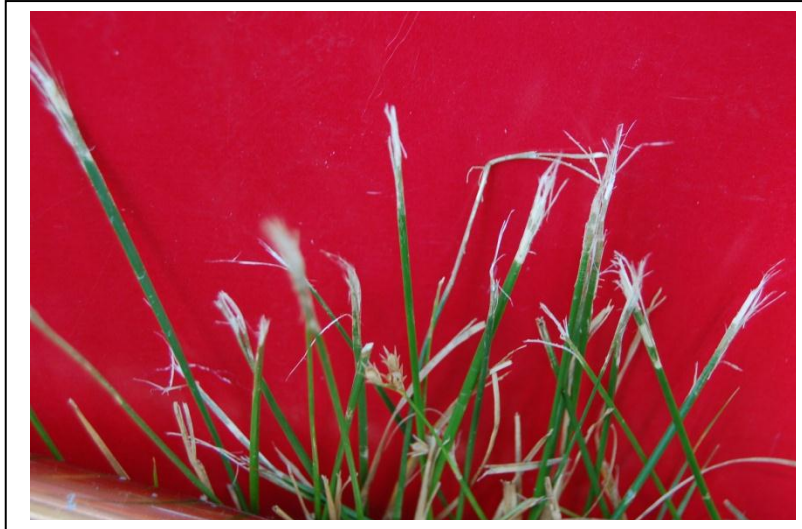
Figure 3-29. Grass at the Elm Street Cemetery has been cut with very dull mower blades, resulting in the leaves being torn, rather than cleanly cut.

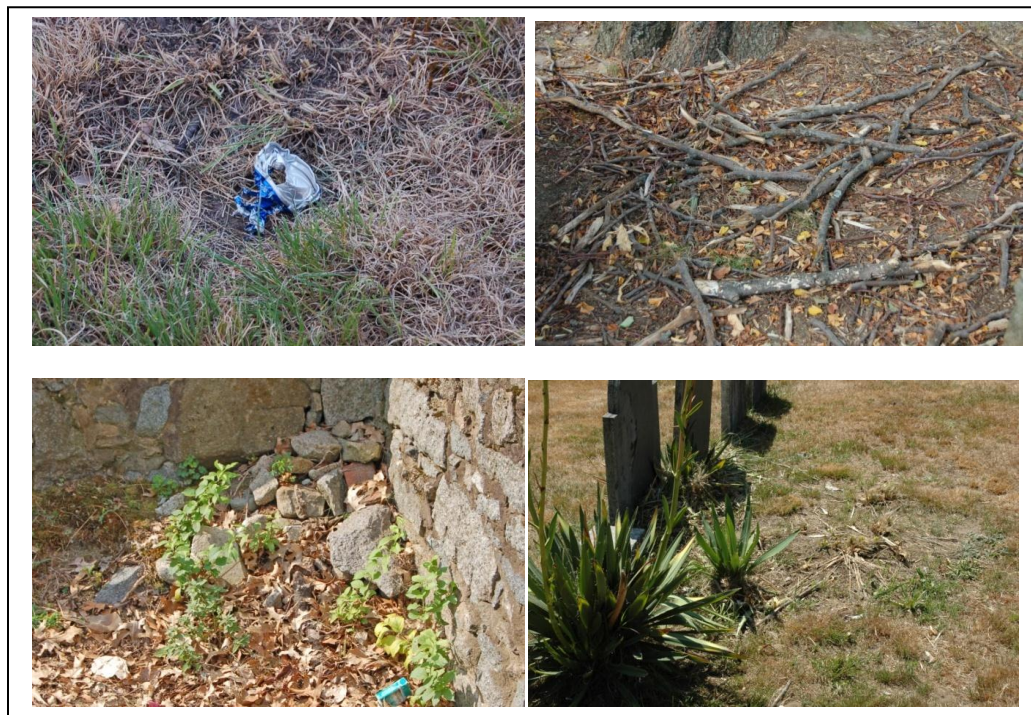
Figure 3-30. Unacceptable mowing practices include a failure to collect trash, litter, and branches prior to mowing and mowing over plantings.

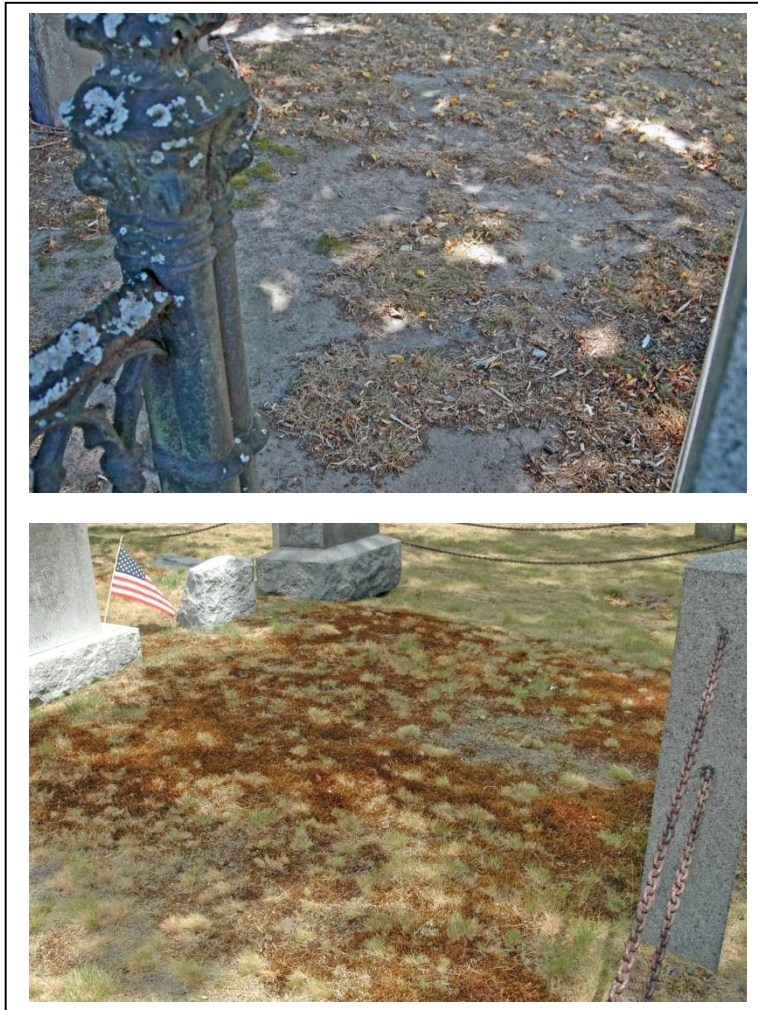
Figure 3-31. Lawn problems. The top photograph shows heavy soil compaction. The bottom photograph shows moss invading the turfgrass.

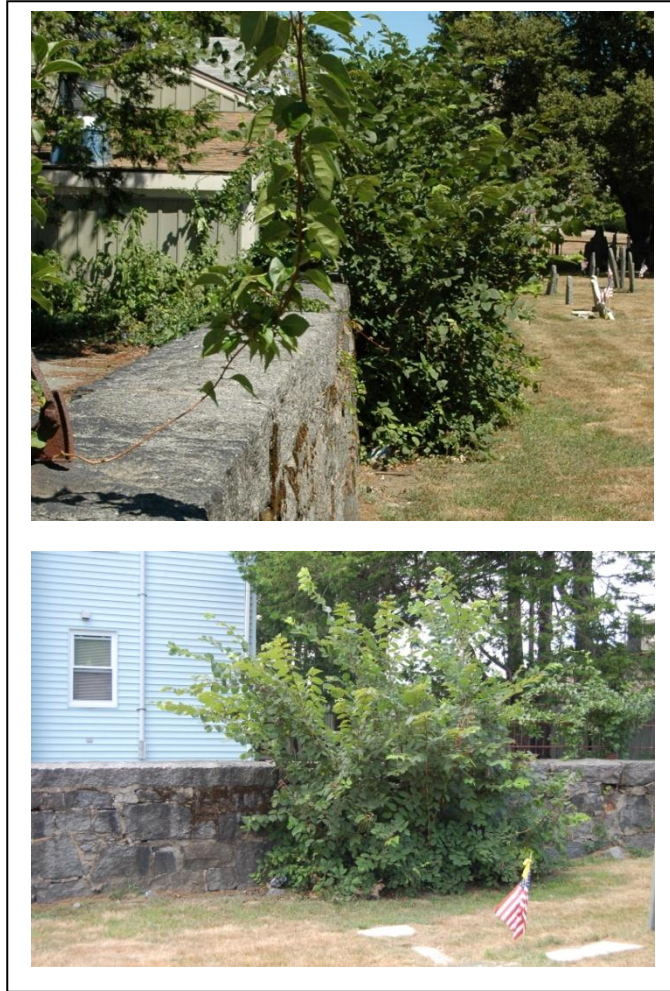
Figure 3-33. Voluntary trees that are detracting from the cemetery landscape and that may cause eventual damage to the cemetery wall. These trees and weedy plants should be removed.

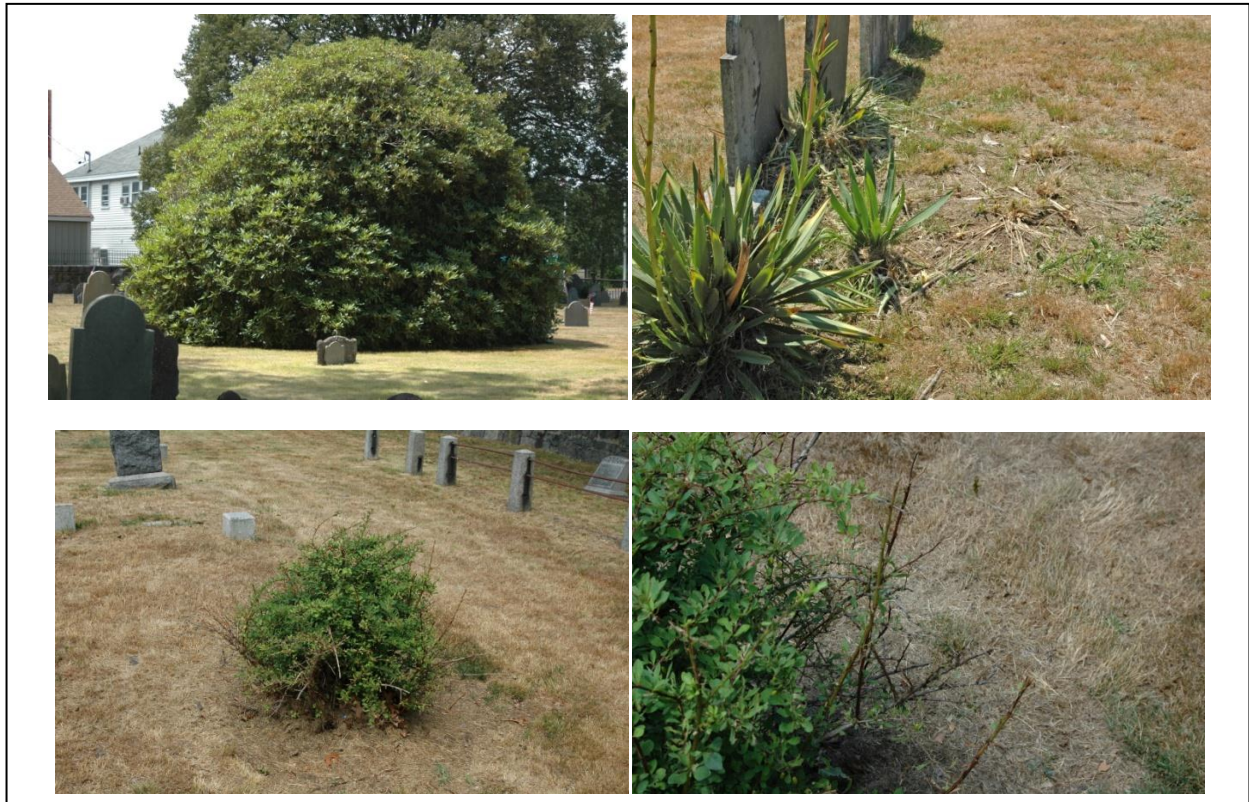
Figure 3-35. Shrubs at the Elm Street Cemetery. Upper left is the Rosebay Rhododendron, an excellent specimen that should be carefully tended. Upper right is an example of the yucca present in the cemetery. Many of these are being mowed over – a practice that should be halted immediately. Lower row shows the barberry that is being improperly “pruned” using a nylon trimmer.

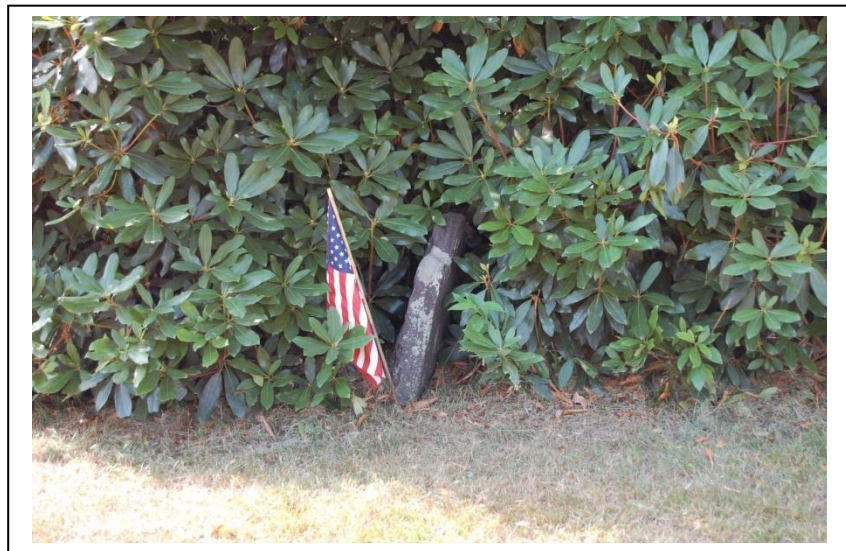
Figure 3-36. Stone at the edge of the rosebay rhododendron. Very judicious and careful pruning can help make the stone more visible without damaging this exceptional specimen.

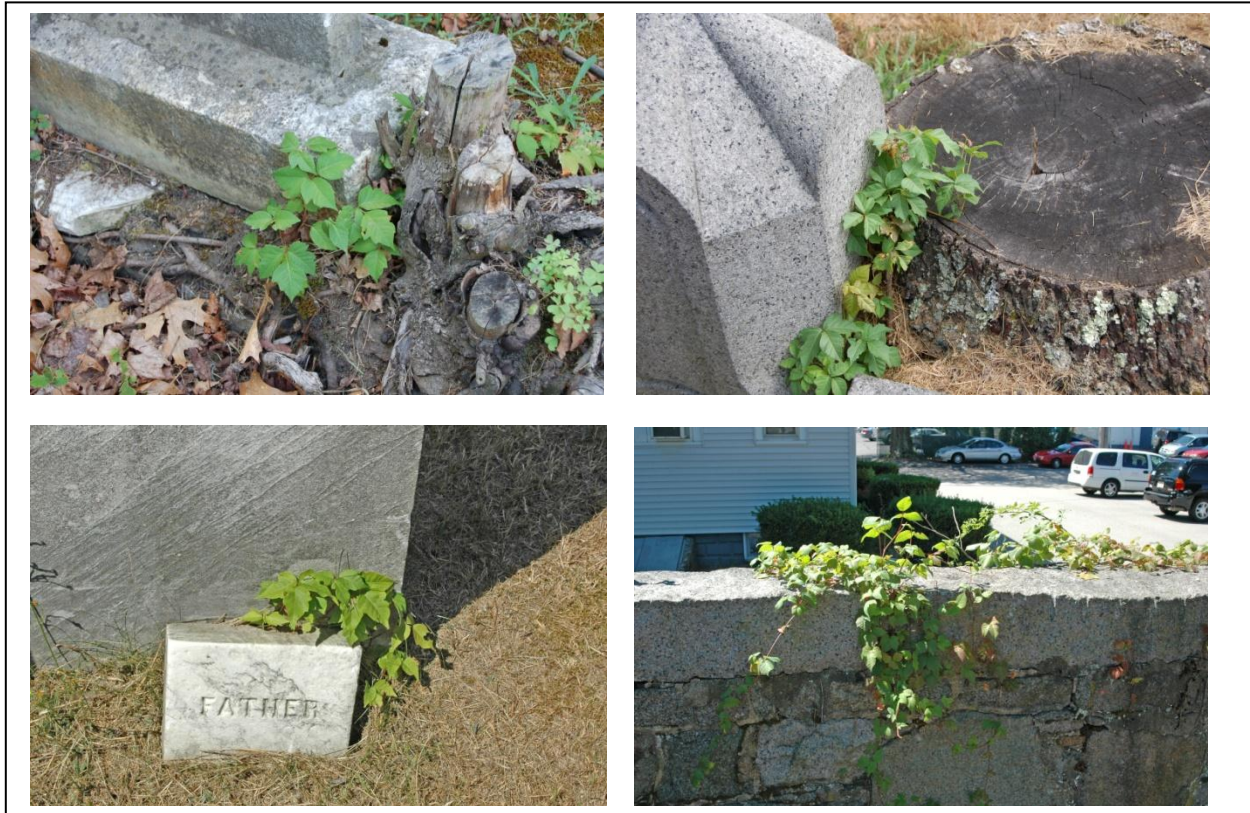
Figure 3-37. Poison ivy is beginning to become established in the cemetery and should be manually removed.

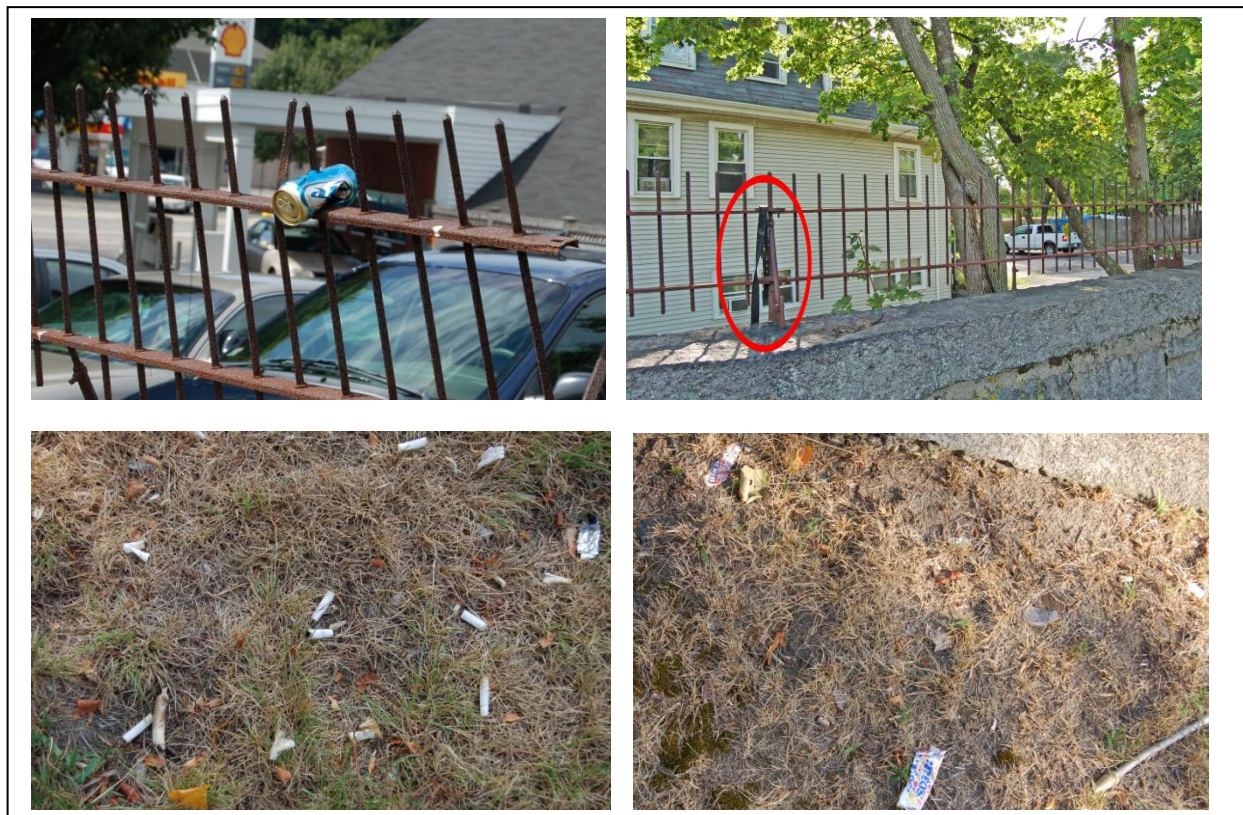
Figure 3-38. Trash at the Elm Street Cemetery.

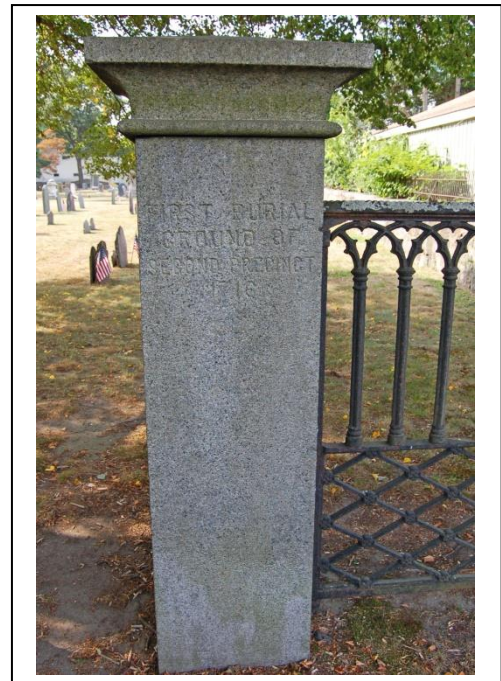
Figure 3-39. The only signage at the cemetery is understated, difficult to see from the street, and fails to promote visitation.

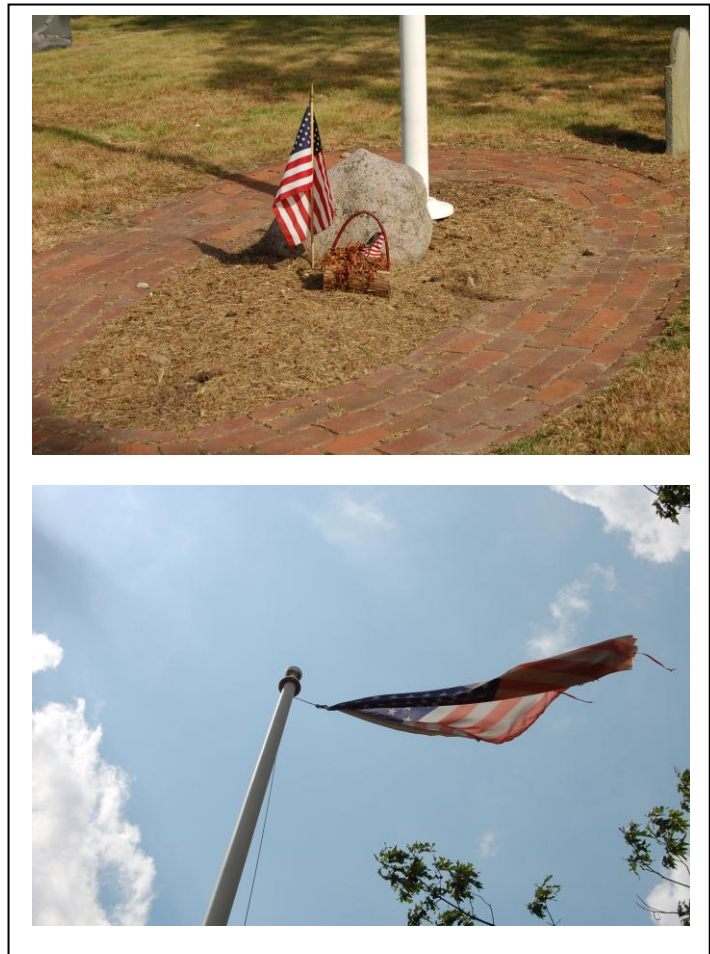
Figure 3-40. Garden and flag at the Elm Street Cemetery are poorly maintained and out of place. They should be relocated to another town property.
